HCH-polluted soils in highly populated areas in "O Porriño" (Galicia, Northwest Spain)

Natalia Crespo González, Francisco Pan-Montojo González, José Rega Piñeiro, Juan Luis Casas

Dirección General de Calidad Ambiental, Consellería Medio Ambiente - Xunta de Galicia

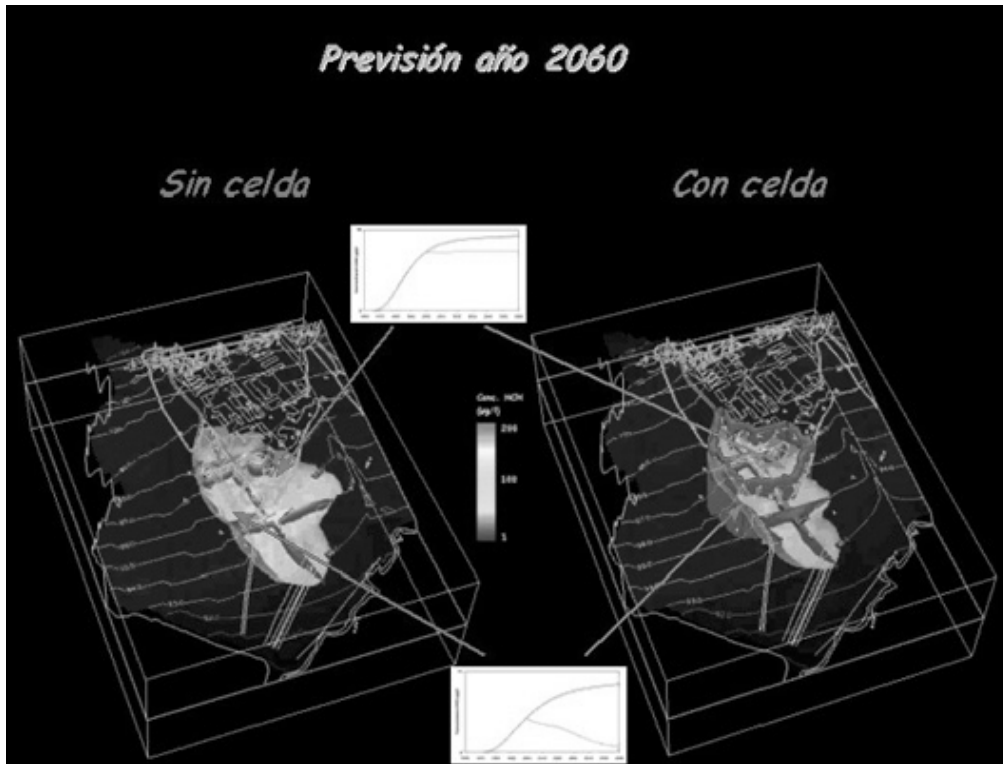
Figure 7. Bentonite-cement panels and their effect

The use of off-site techniques for the remediation and/or encapsulation, in the first area investigated, was too expensive in the given circumstances (dispersion of contaminants in large quantities of soil). Besides, the possible dispersion caused by the movement of soil would increase the health risk for the population. This situation and the knowledge of the behaviour of groundwater pollution recommended the encapsulation of the principal source, with vertical panels of bentonite-cement, 30 m maximum depth (to embed them into the granite mother rock). With this method contaminants are isolated from groundwater (Figure 7).
