MINAS DE ALMADÉN Y ARRAYANES, S.A.,S.M.E.

**REMEDIATION OF MERCURY CONTAMINATED SITES.
THE CASE OF “CERCO SAN TEODORO” ALMADEN
DUMP AND THE OLD MERCURY METALLURGY
FACILITIES OF THE CERCO DE ALMADENEJOS**

Ana I. Conde/ F. Javier Carrasco

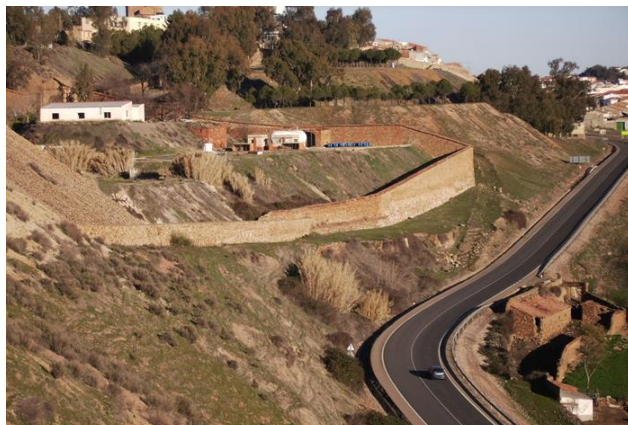
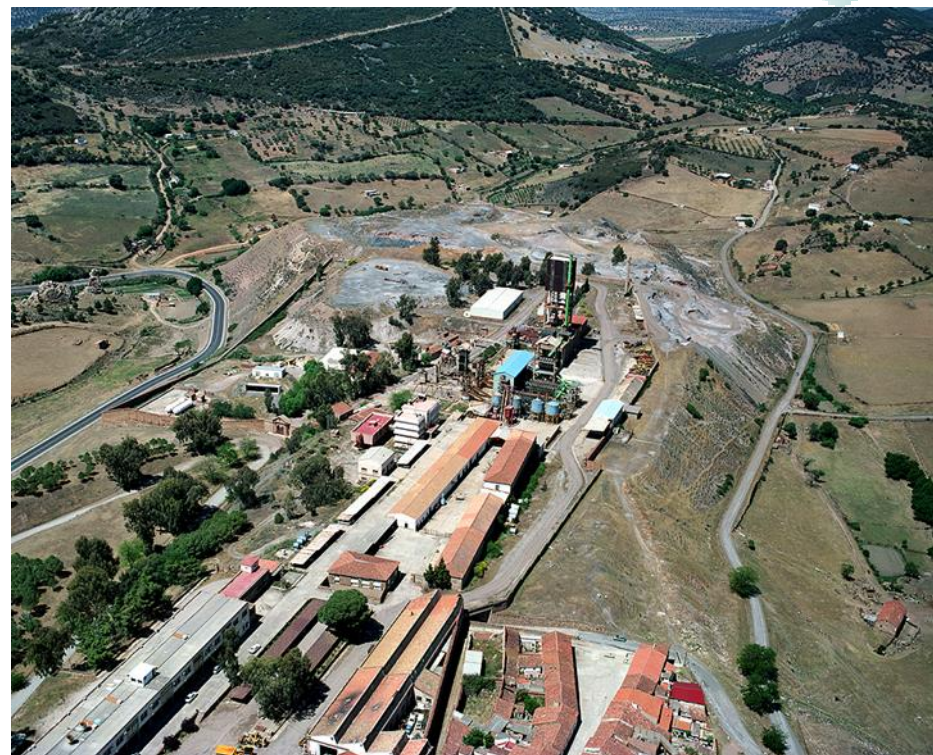
DUMP GEOMETRIC CHARACTERISTIC

OCCUPIED AREA (ha)	9,1
TOP AREA (ha)	4,9
SLOPE AREA (ha)	4,2
WASTE AMOUNT (t)	3,500,000
MAXIMUM HEIGHT (m)	58,7
MEDIUM SLOPE ANGLE	36º
PERIMETER (m)	865

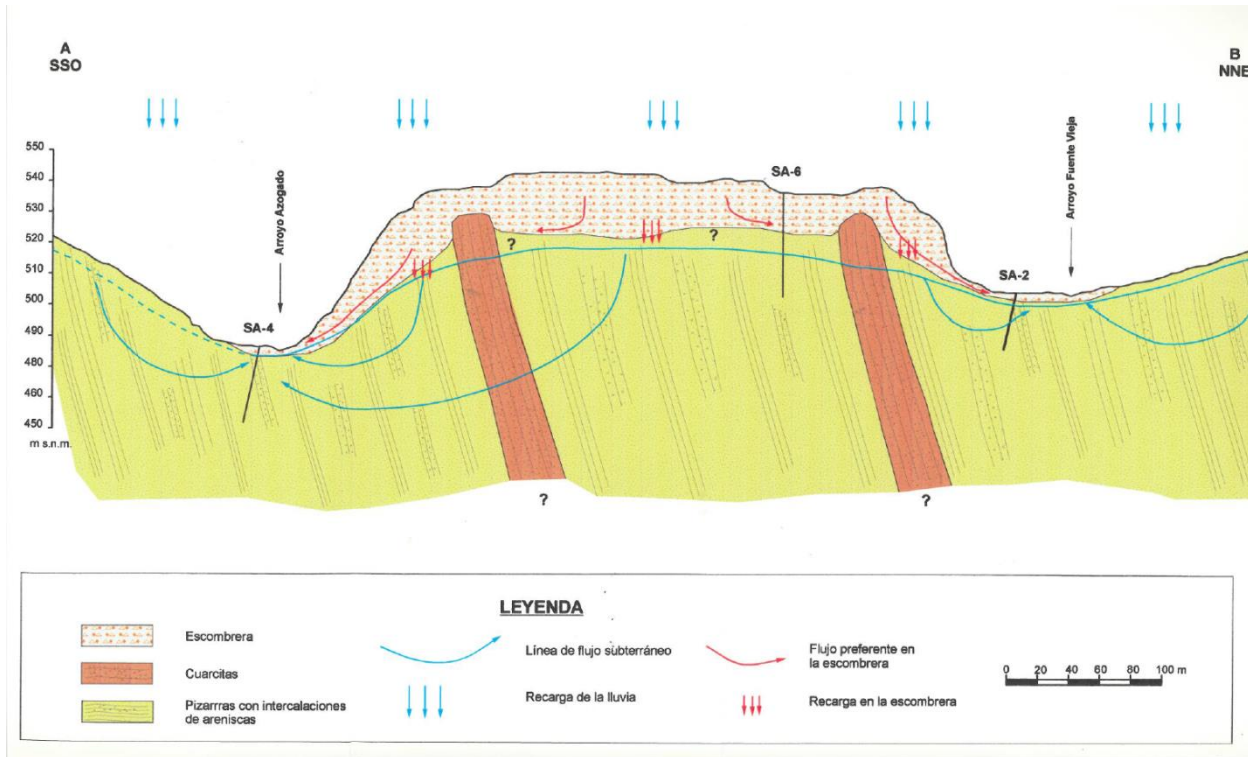
The hydraulic characterization showed the permeability of the dump is much higher than that of the land on which is located, the water table is very close to the ground surface (about 3 or 4 m). This shows that the dump is on the ground water of the site. There is a radial flow to north, west and south. Despite the near proximity of the mine (that it is seven hundred meters deep), the water table remains in its position, it shows the low permeability of the ground.

The water comes only from the rain and goes through the dump and it is discharged to the surrounding streams: in the north and west, the Fuente Vieja stream and in the south, Azogado stream.

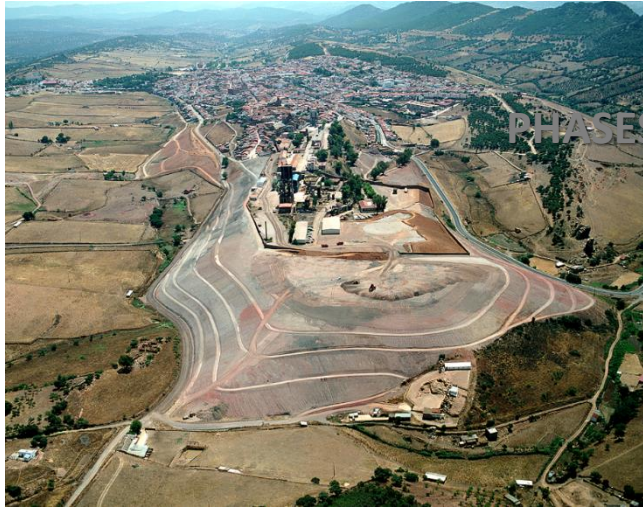
1. DUMP FORMING

- Remodel the slopes and the capping plate of the dump
- Stabilizing their conditions
- Earth filling of 493,582 m³ of material

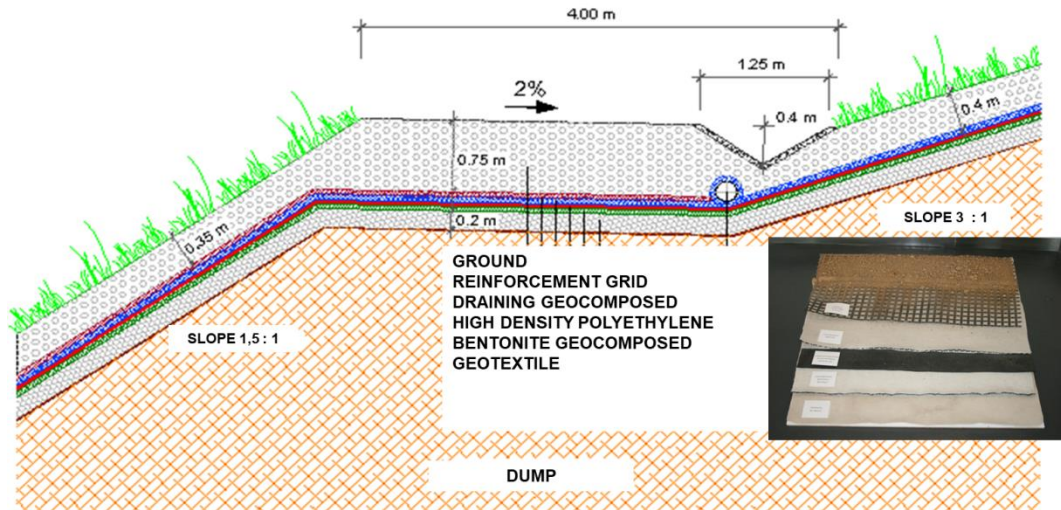
SEALING SURFACE SCHEME
LOW INCLINATION SLOPE

ESQUEMA DEL TALUD / CUMBRERA DE LA ESCOMBRERA

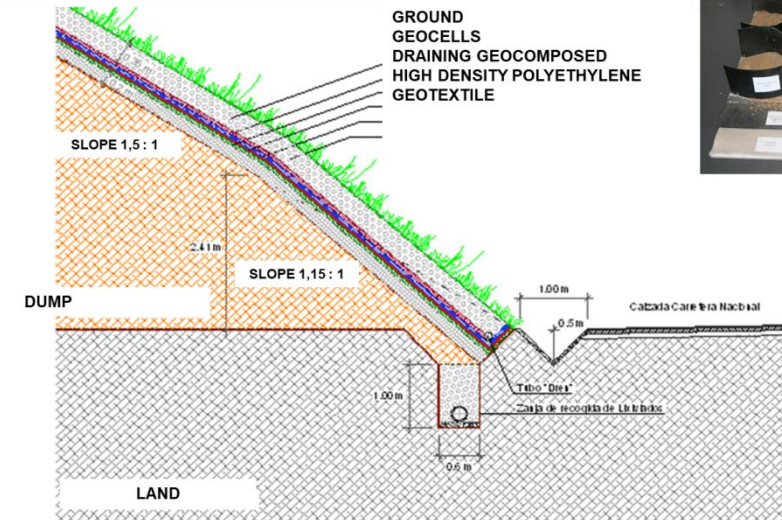
SEALING SURFACE SCHEME
HIGH INCLINATION SLOPE

ESQUEMA DEL TALUD / PIE DE LA ESCOMBRERA

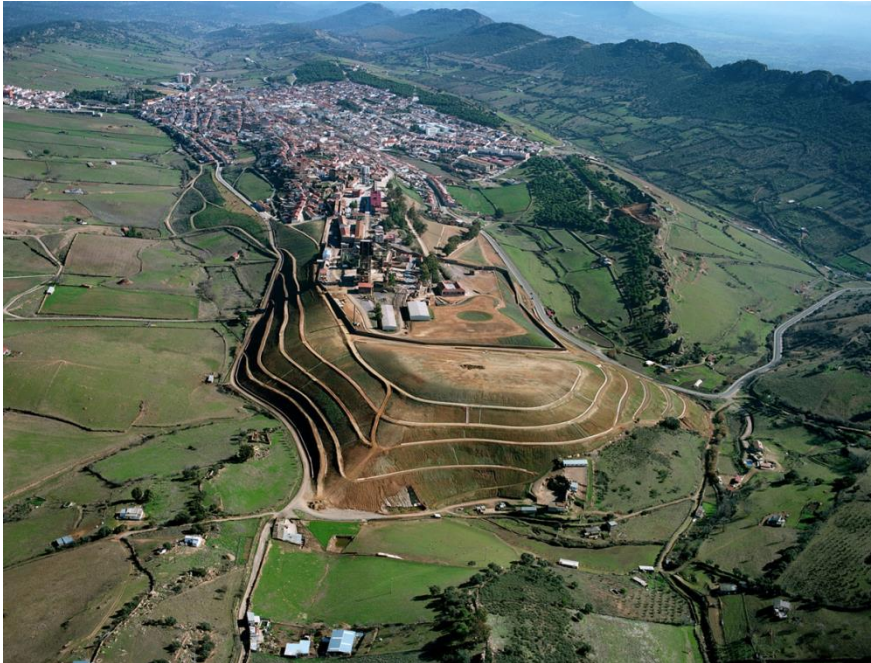
3.INSTALLATION OF A COLLECTION, CIRCULATION AND EVACUATION WATER SYSTEM

Aim: To avoid the erosive effects which can affect the dump stability

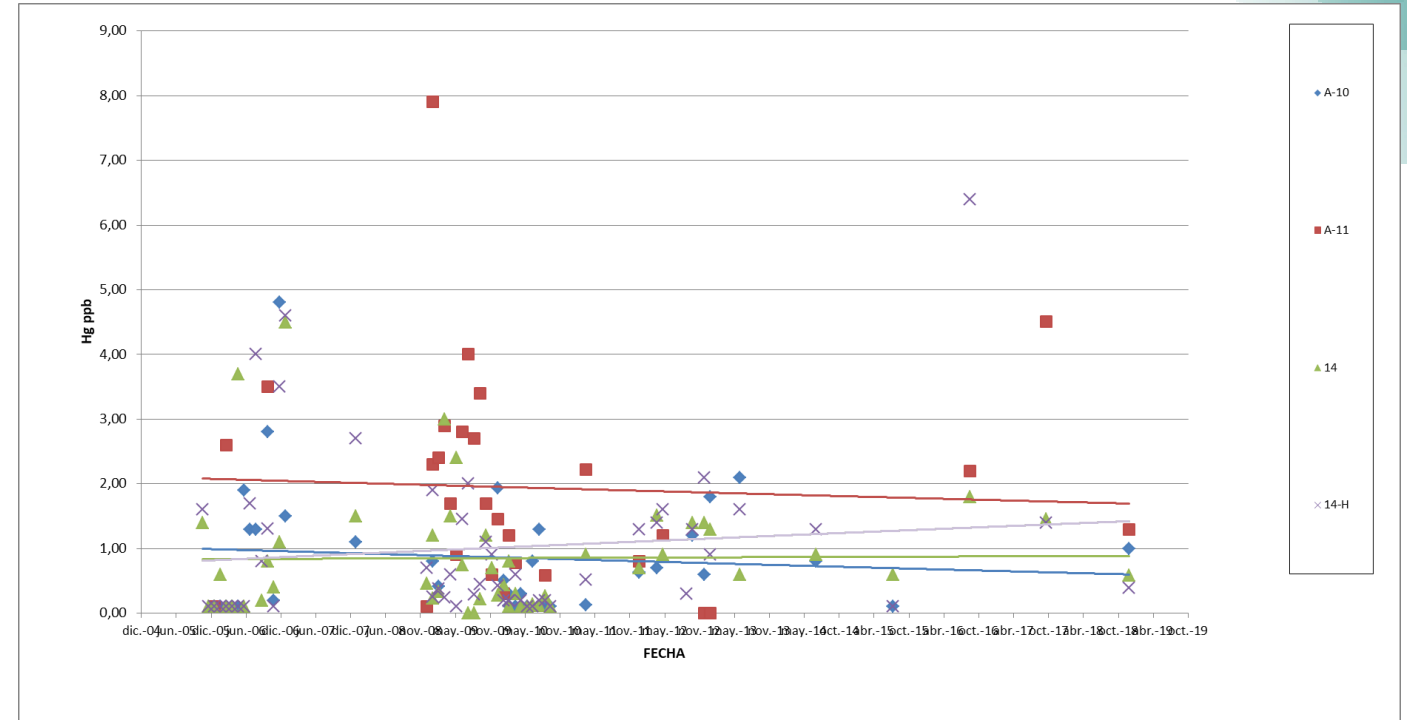
WATER MONITORING GROUNDWATER: WELLS AND SPRINGS

AZOGUE GIS WEB Geographic Information System which store the environmental information about the restoration project of the Almaden dump. More information in this web site. <http://www.ctndm.es/proyectos/1.php>

The restoration works are reducing:

- The material dispersion and mercury evaporation
- The lixivate production which had as final destination the surrounding streams
- The underground flow below the dump
